**Re: Supplemental Asbestos Inspection  
Former Perry & Derrick Facility  
2511 Highland Avenue  
Cincinnati, Hamilton County, Ohio**

SRW has prepared this report to document a supplemental asbestos inspection of the former Perry & Derrick facility. The services were provided using funding from a community-wide brownfield assessment grant for petroleum and hazardous substances awarded to the City of Norwood by the United States Environmental Protection Agency (USEPA) in 2014.

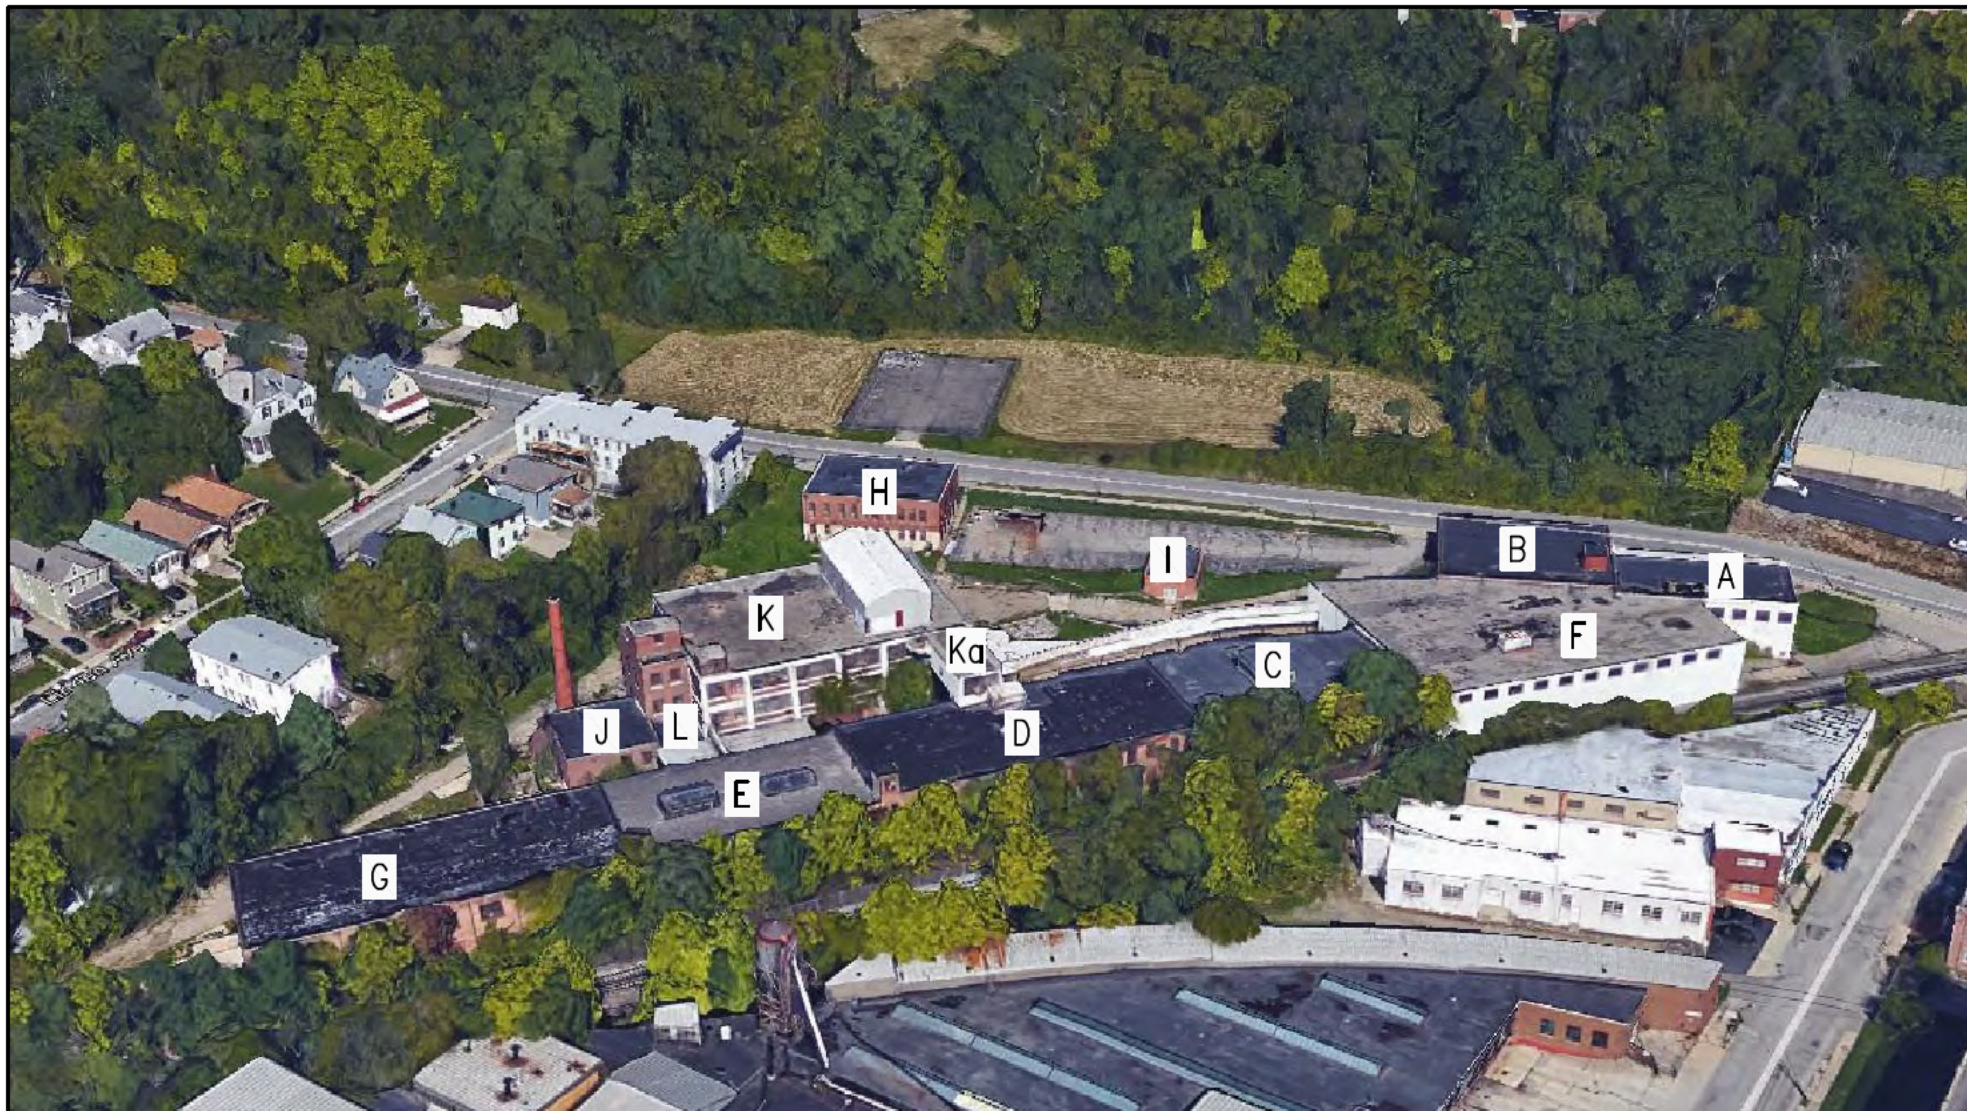
**BUILDING LOCATIONS (DETAILED)**  
**FORMER PERRY & DERRICK FACILITY**  
**2511 HIGHLAND AVENUE**  
**NORWOOD, HAMILTON COUNTY, OHIO**
